**AERIALY DEPOSITED LEAD (ADL)
INVESTIGATION REPORT**
Barton Road Interchange with the I-215 Freeway
San Bernardino County, California

Prepared for:
AECOM/LAN Engineering Corporation
999 W. Town & Country Rd
Orange, California 92868

May 10, 2010

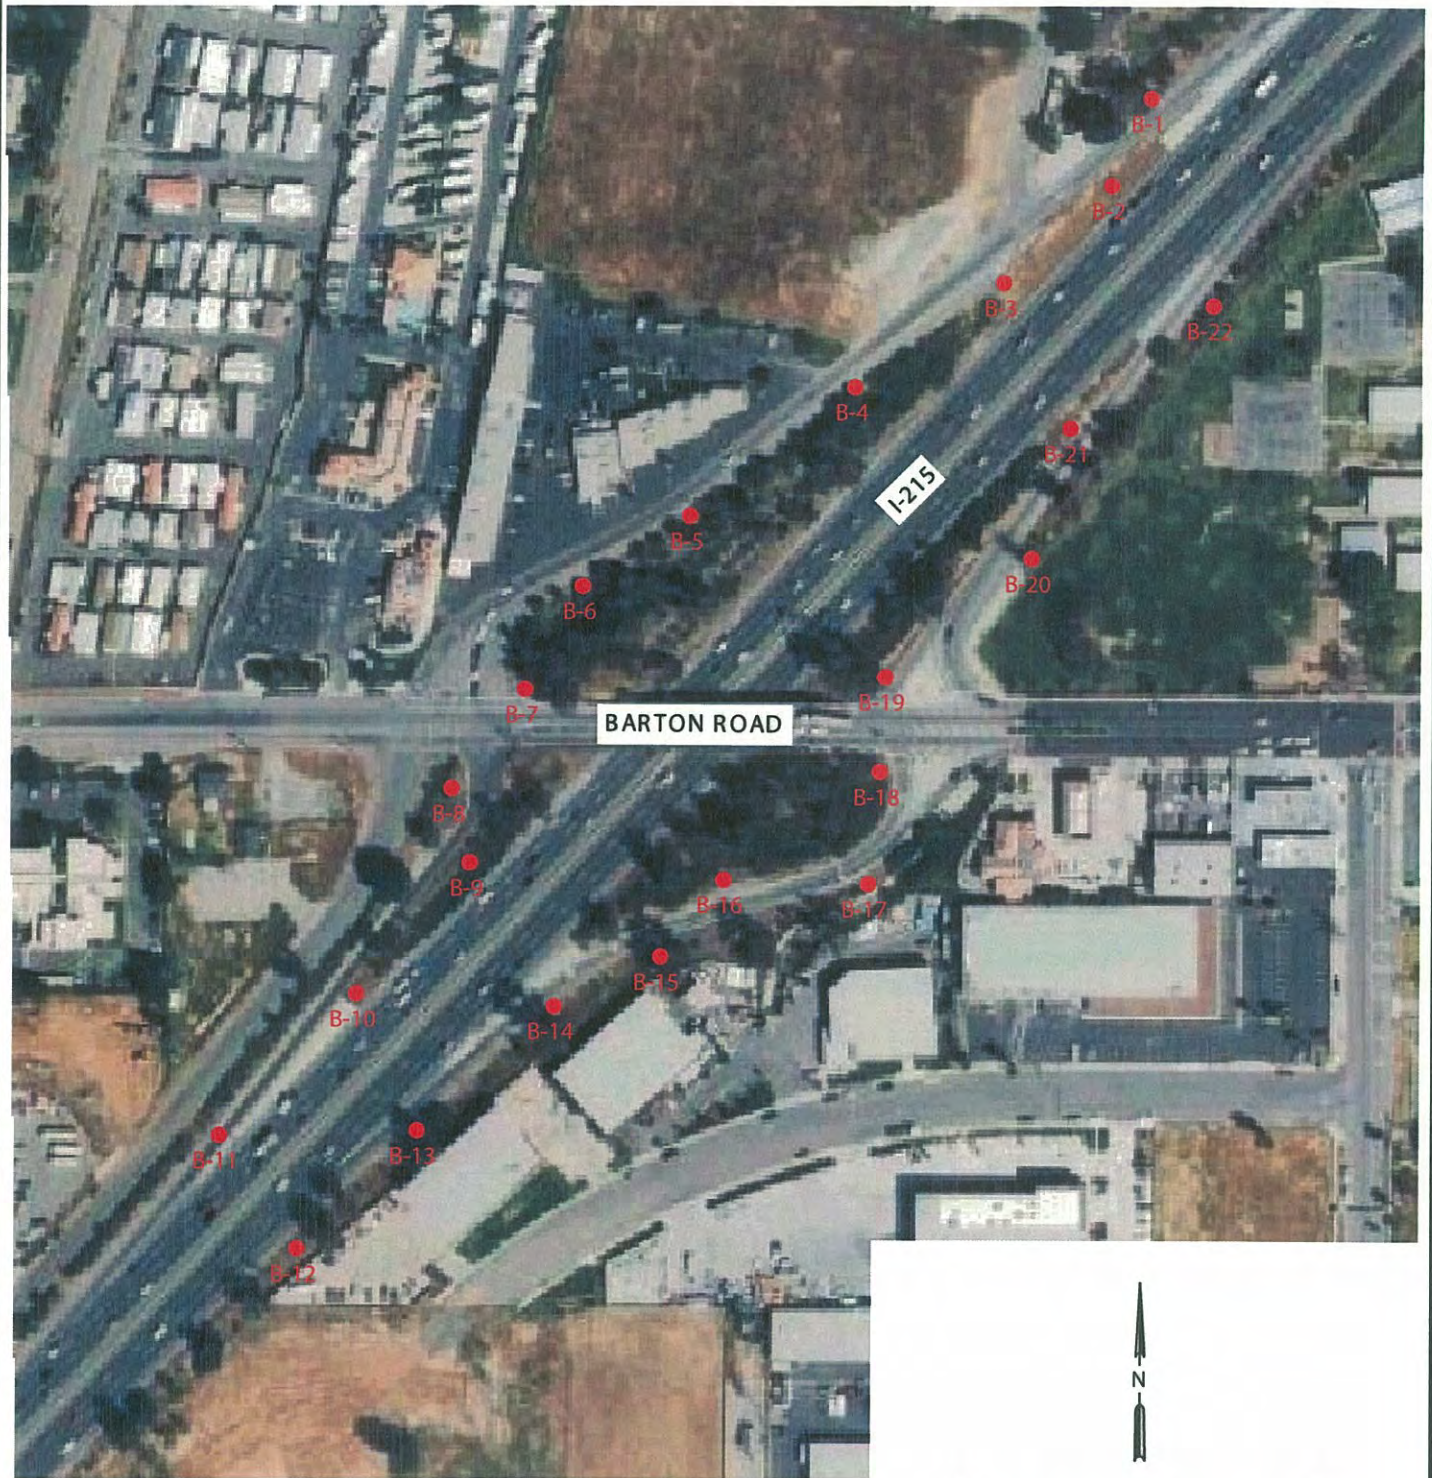
- SOIL BORING (HAND AUGER) LOCATION AND NUMBER

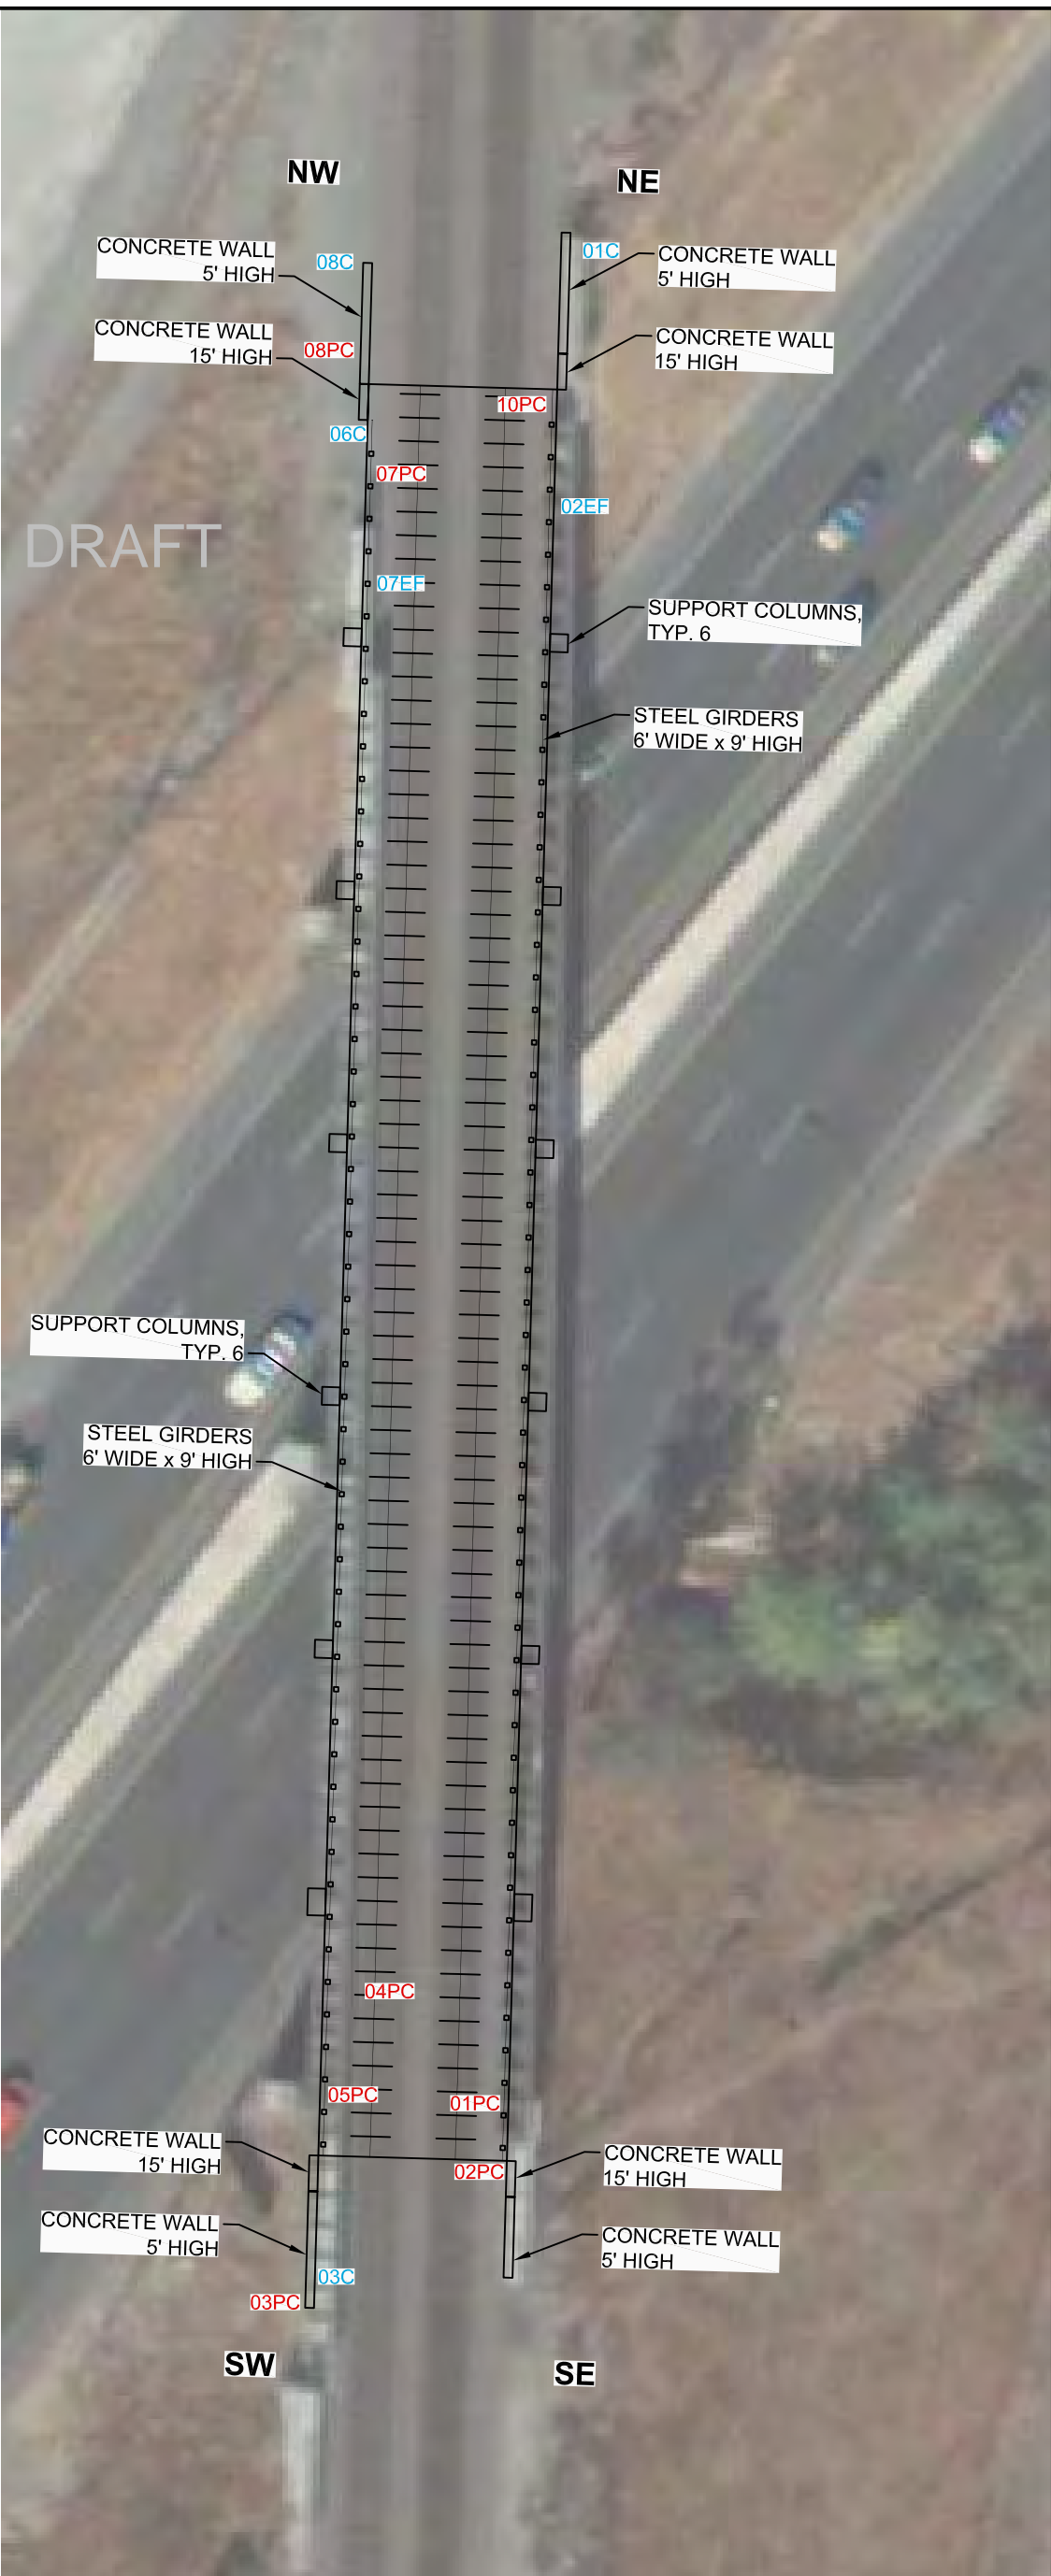
- **LBP SAMPLES**
 - The painted surfaces along the railway bridge structure were in relatively good condition with no peeling or flaking visible.
 - Ten (10) samples (PC-1 to PC-10; Figure 3) were submitted for analysis of lead based paint.
 - Reported concentrations ranged from 160 to 64,500 mg/Kg. Six (6) of the samples reported lead concentrations exceeding the California Hazardous Waste level of 1,000 mg/Kg.

- **ACM SAMPLES**
 - The suspect asbestos containing materials along the railway bridge structure were in relatively good condition. The shims would be considered friable materials but were in good condition.
 - Ten (10) samples (01 to 10; Figure 3) were submitted for analysis of asbestos.
 - Asbestos was detected at 85% in all four (4) shim samples. Asbestos was not reported above reporting limits in the concrete and expansion joint felt samples.

- SHIMS
- SUPPORT BEAMS (NO SHIMS)
- SAMPLES**
 - PC -PAINT CHIP
 - C -CONCRETE
 - EF -EXPANSION JOINT FELT
 - S -SHIM
 - PW -PIPE WRAP (INSULATION)
